# An Introduction to Geosynthetic Cementitious Composite Mats (GCCM), (Concrete Cloth)

Michael Close, PE  
Senior Sales & Technical Service Engineer  
Milliken Infrastructure Solutions, LLC

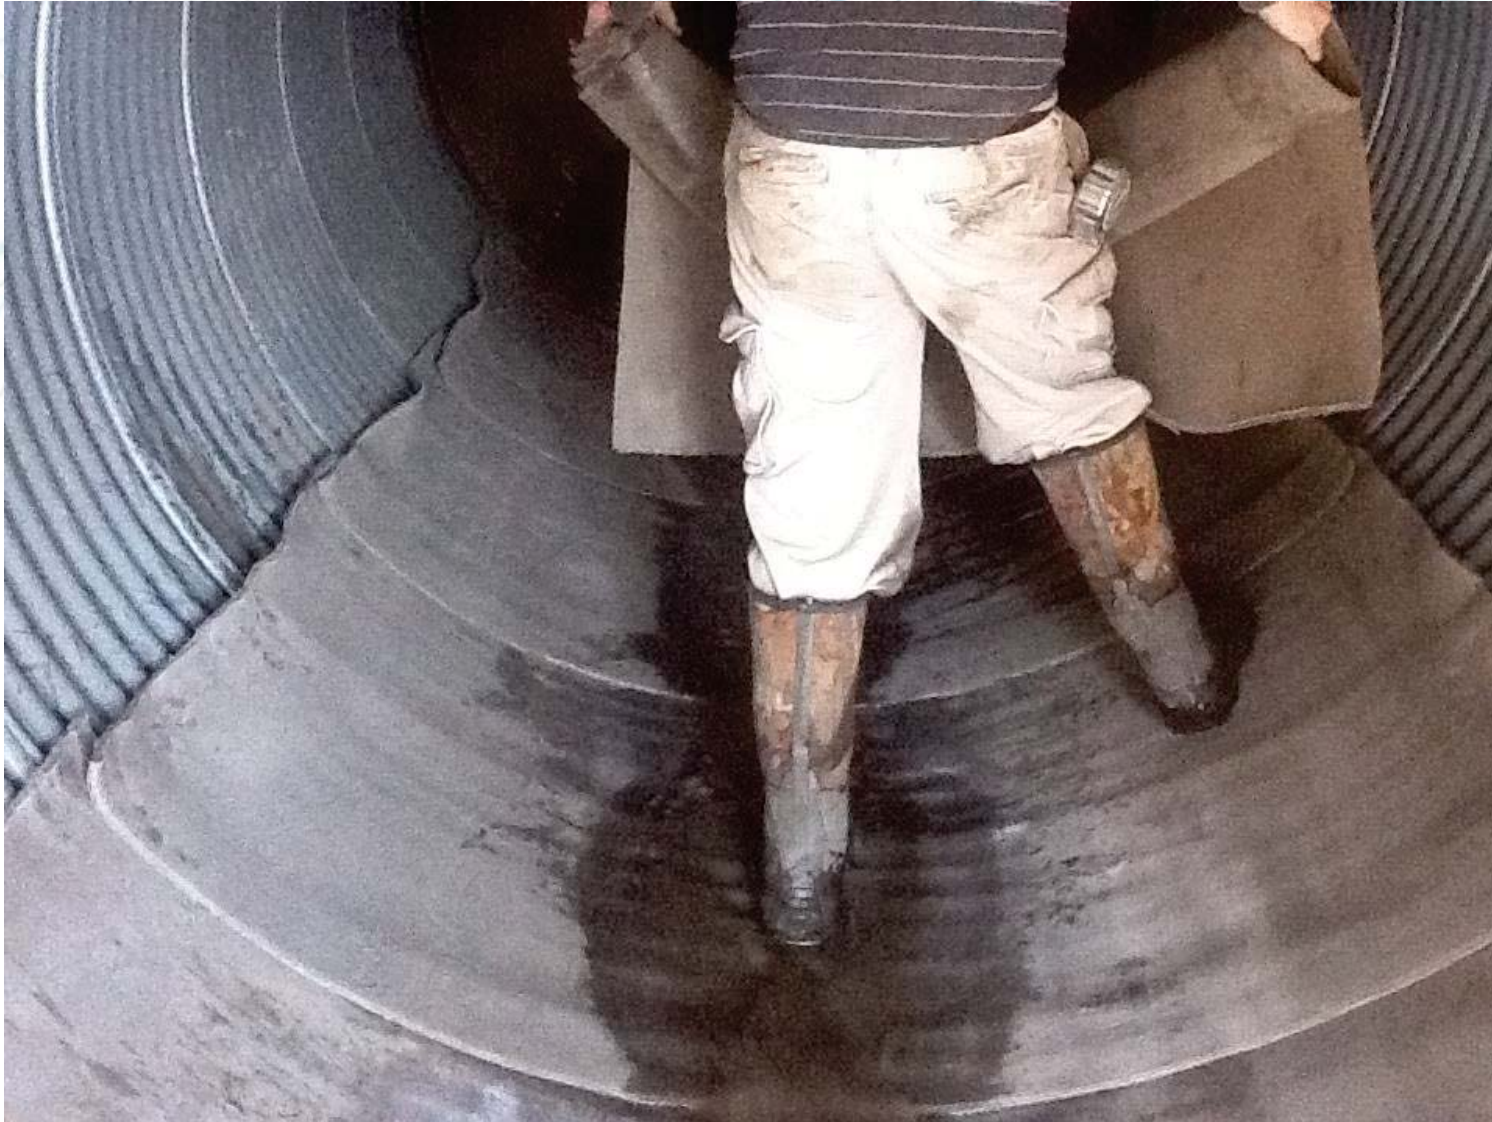
The invert of dual 72 inch diameter galvanized corrugated metal pipe (CMP) culverts had rusted through in some sections and the county decided to use Concrete Cloth CC8 to repair the areas of concern to add years of service to the existing culverts instead of replacing the culverts.

Concrete Cloth placed perpendicular to the direction of flow.

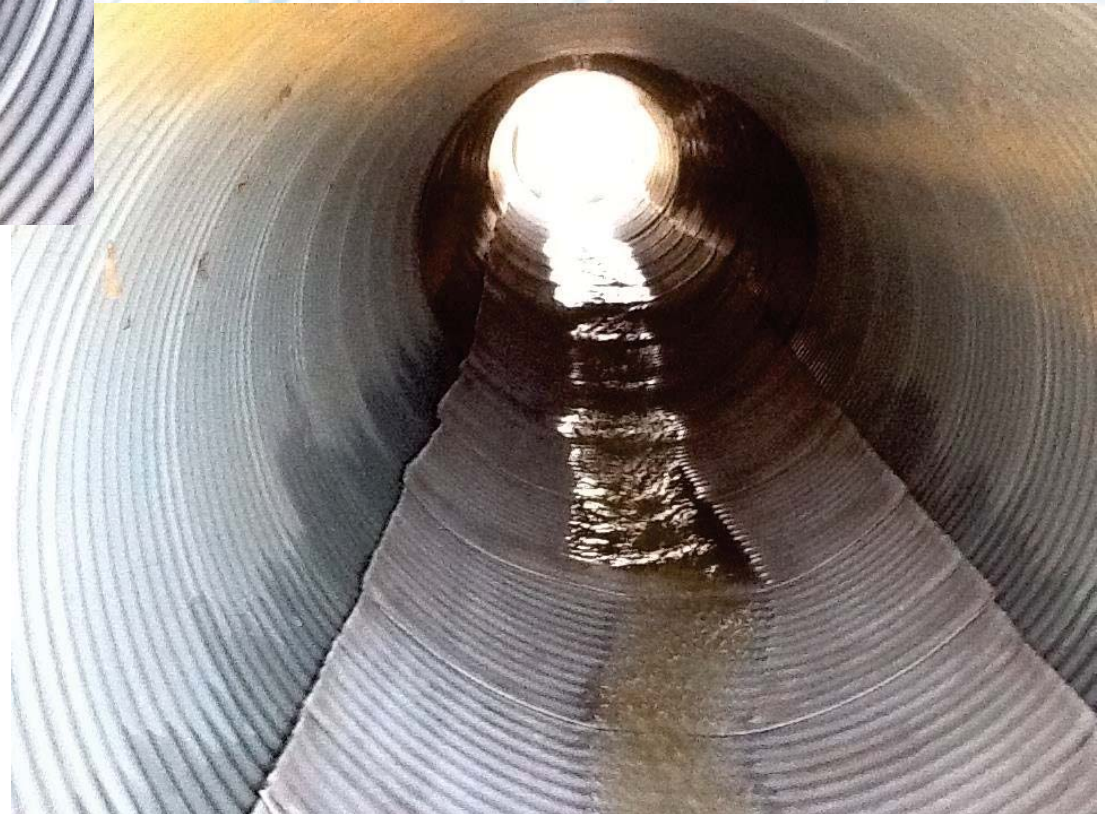
Water flowing through the pipe was also used to hydrate the Concrete Cloth

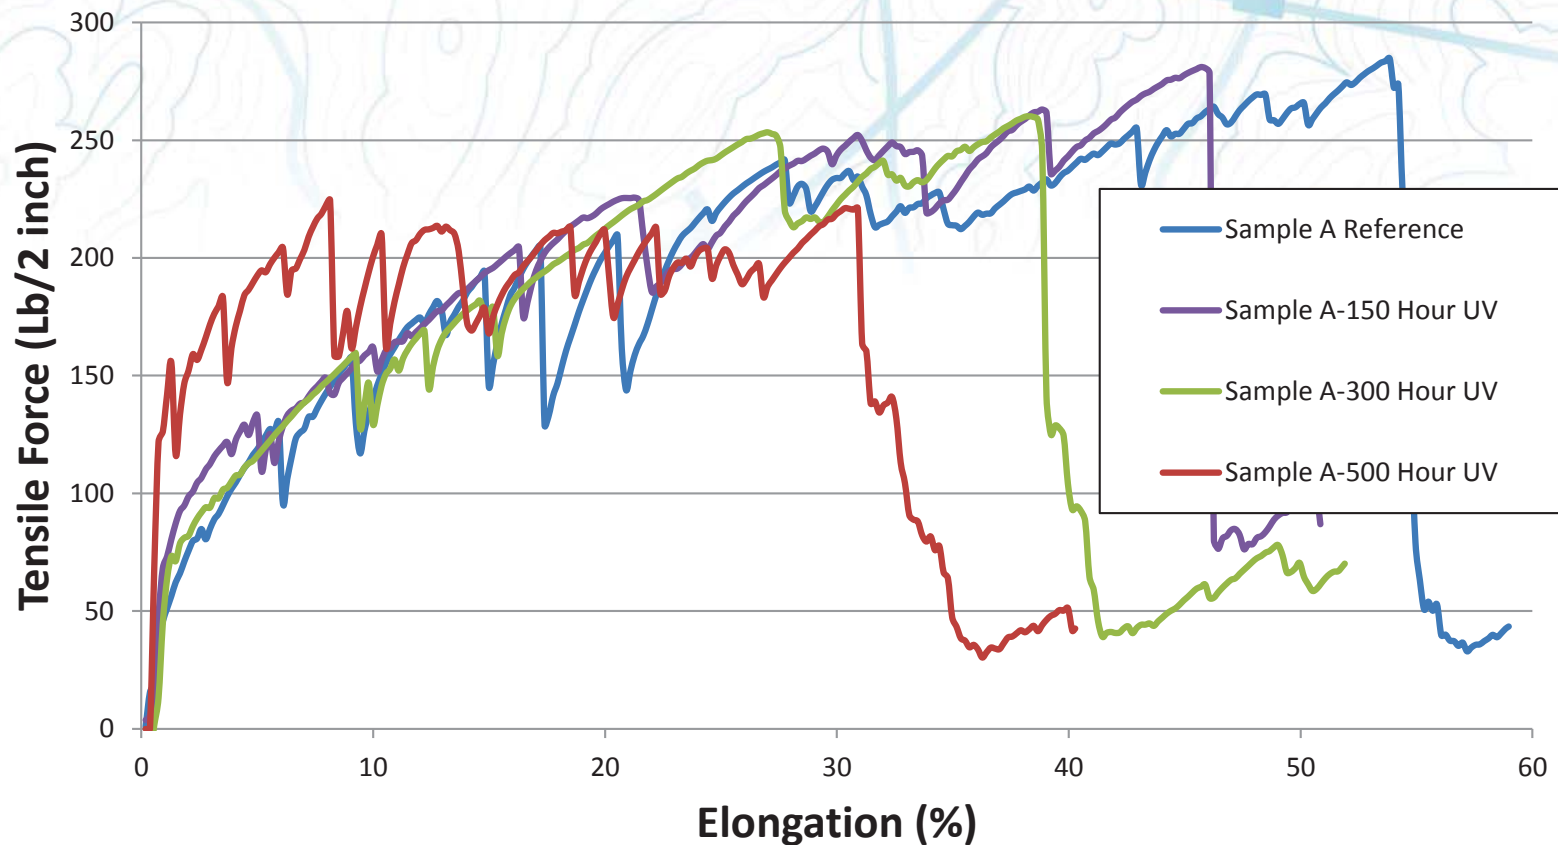
Exposed according to ASTM D4355  
Tested according to ASTM D5035

## Cross Machine Direction Tensile

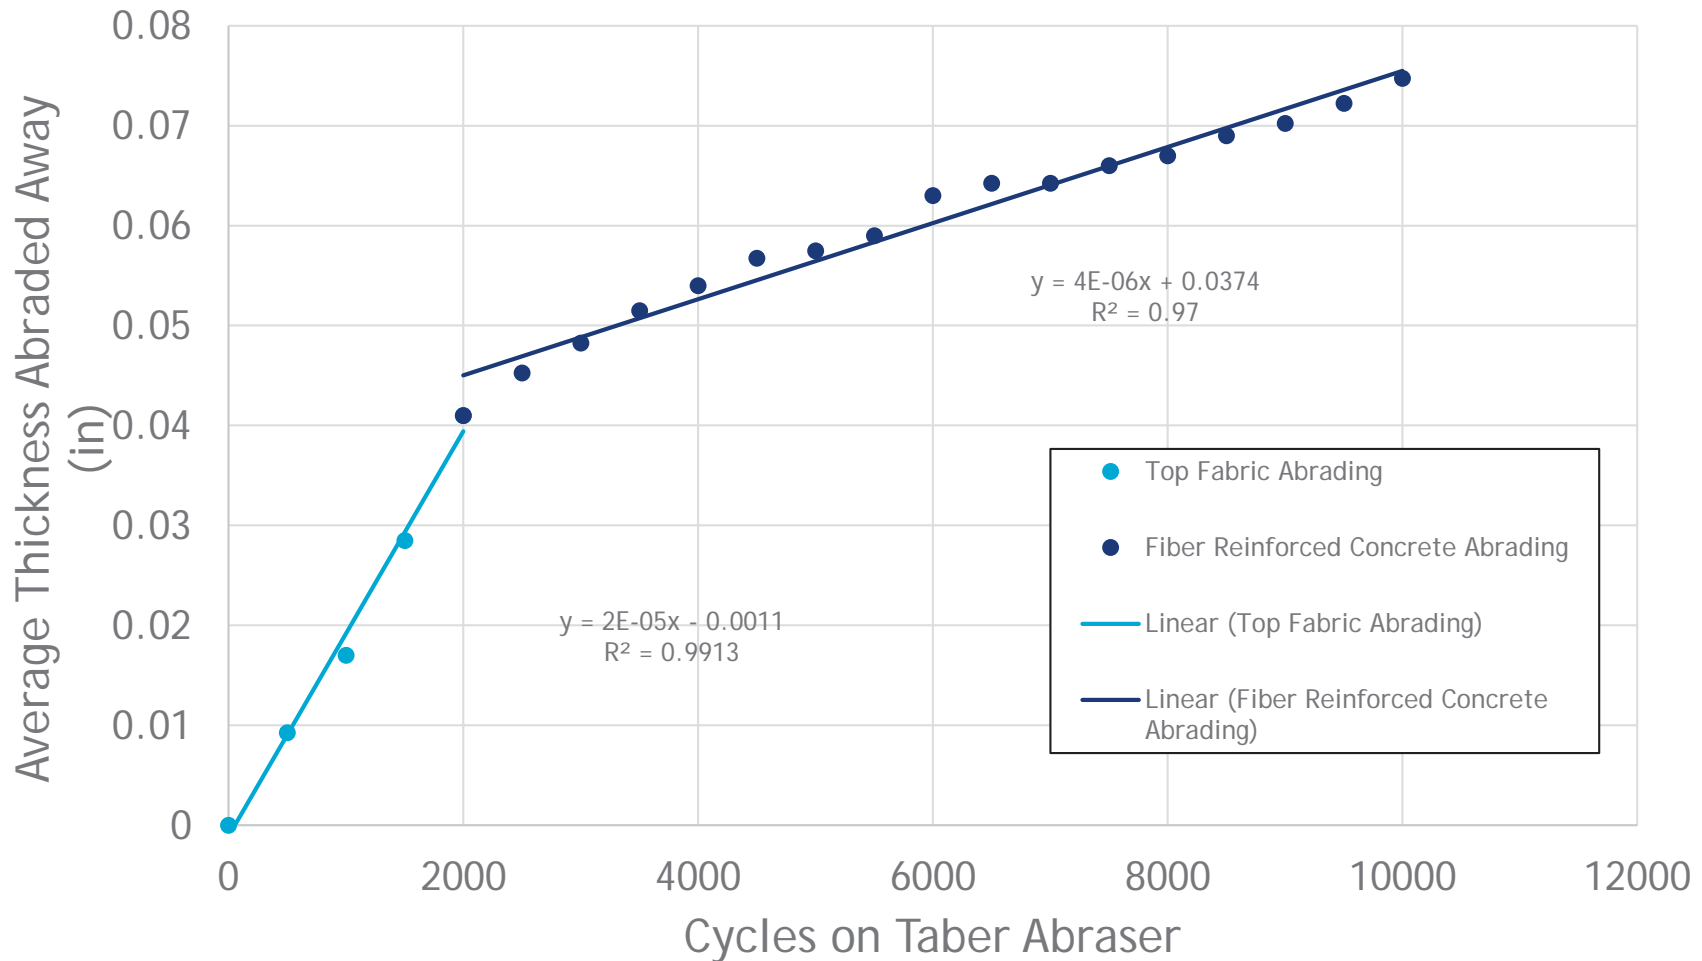
# Images of Abraded CC8

- Faster rate of abrasion until top fabric surface removed (~2000 cycles)
- Estimate ~70000 cycles to abrade away thickness

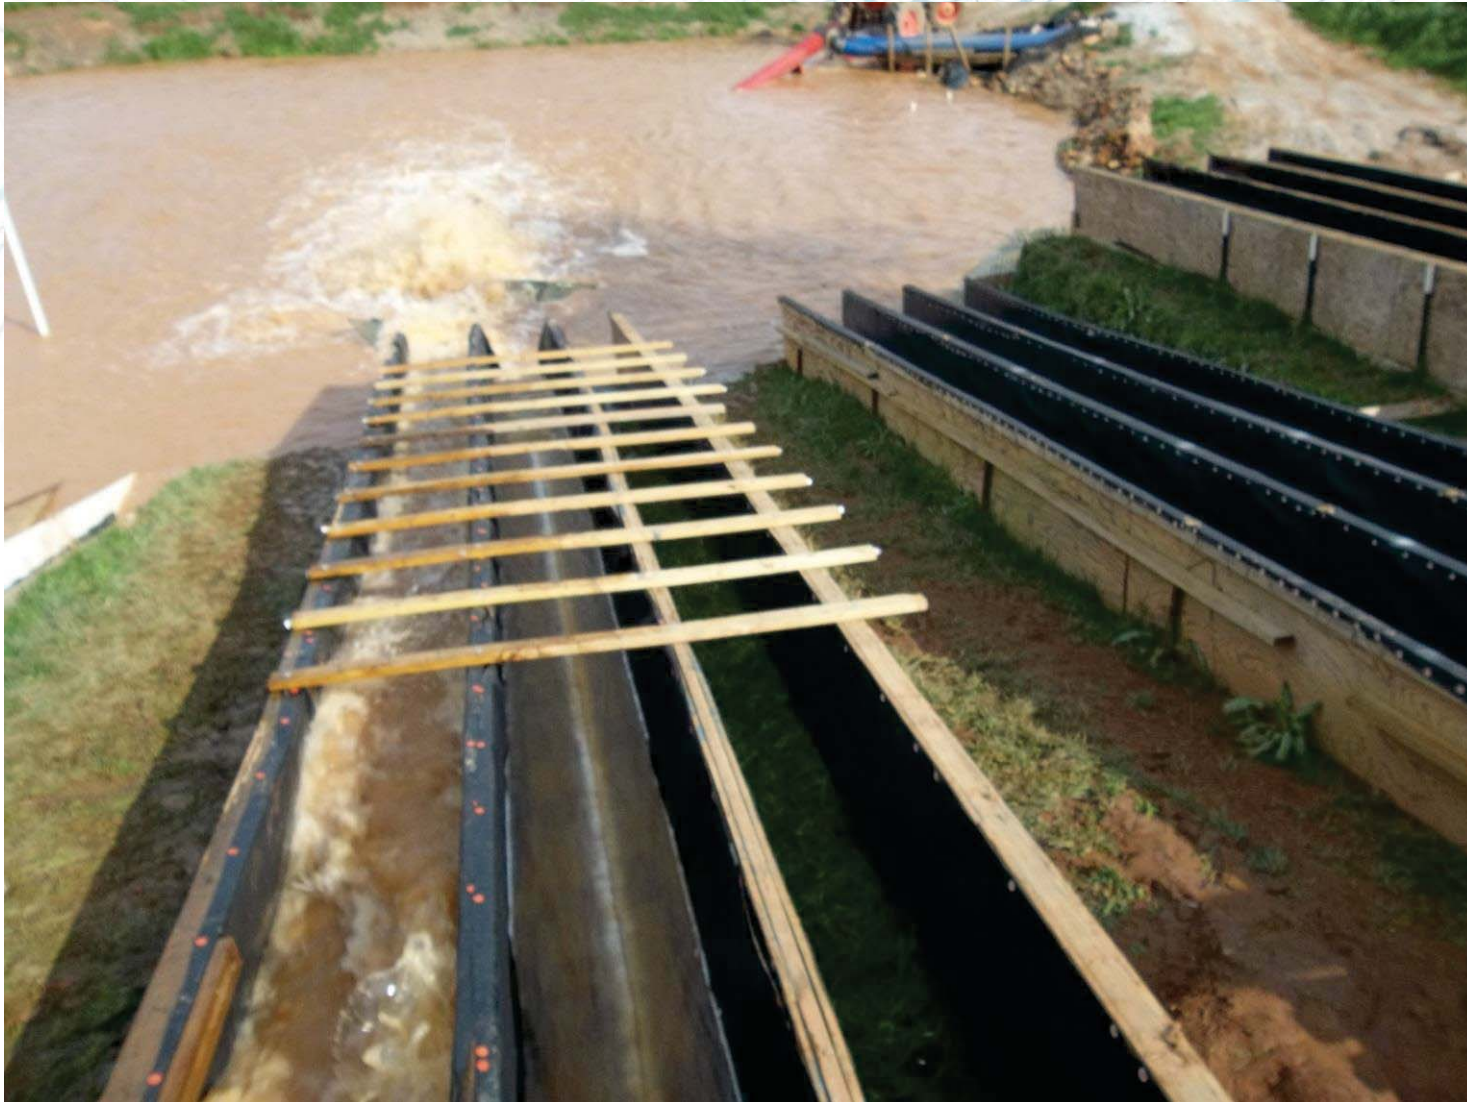
# TRI Environmental - Concrete Cloth High Flow Testing

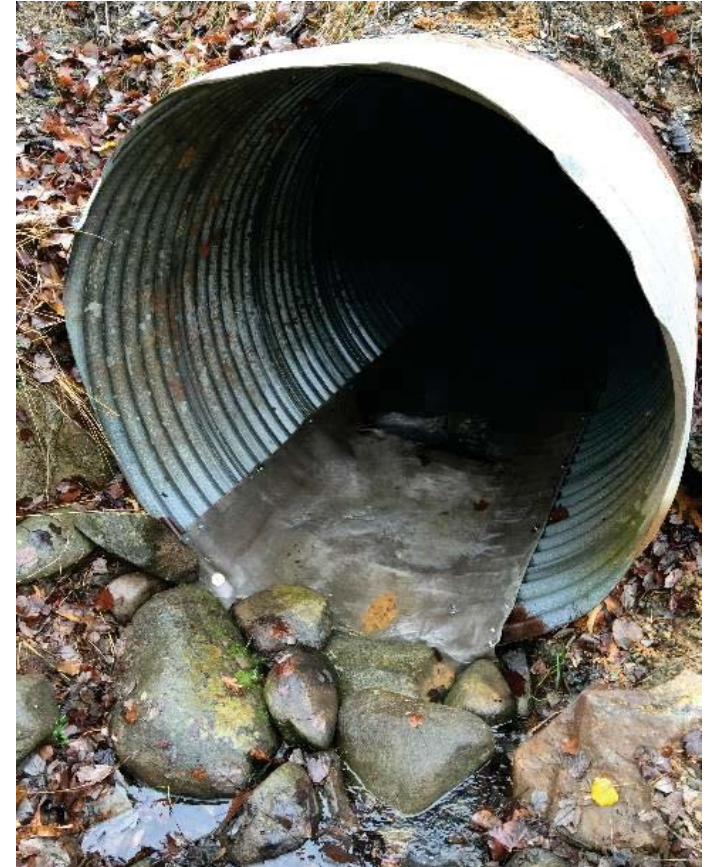
Concrete Cloth lining of a corroded culvert in Seymour, TN with an active stream

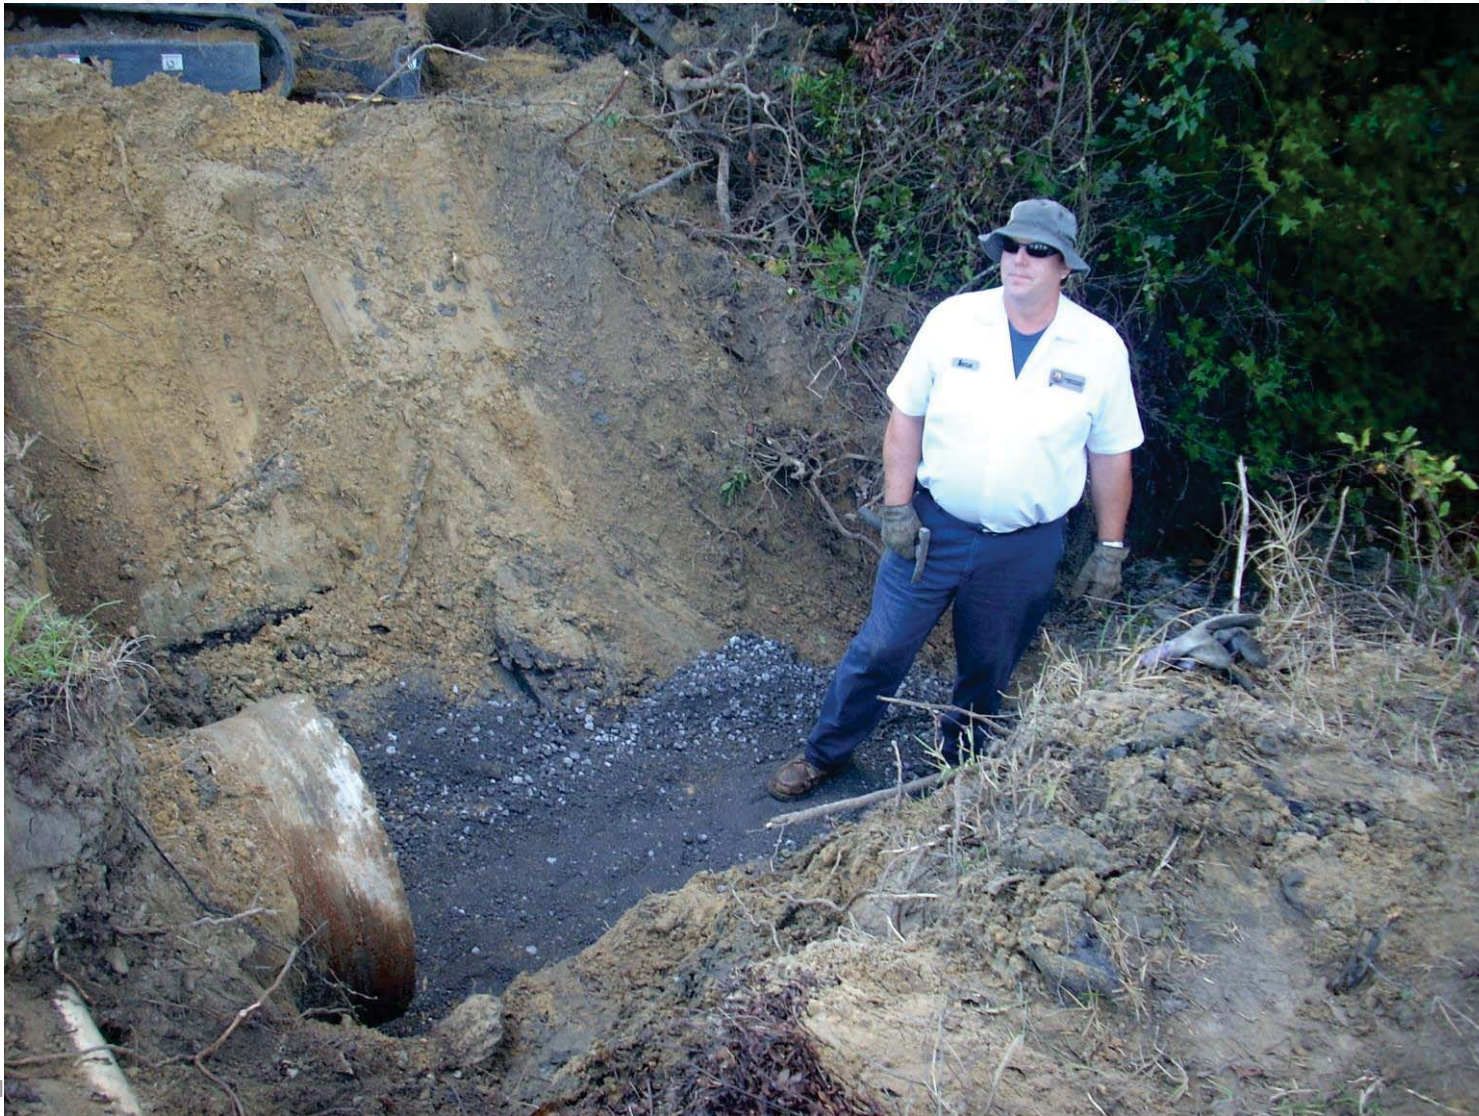
The pipe joint was exposed, and the bed was re-graded.

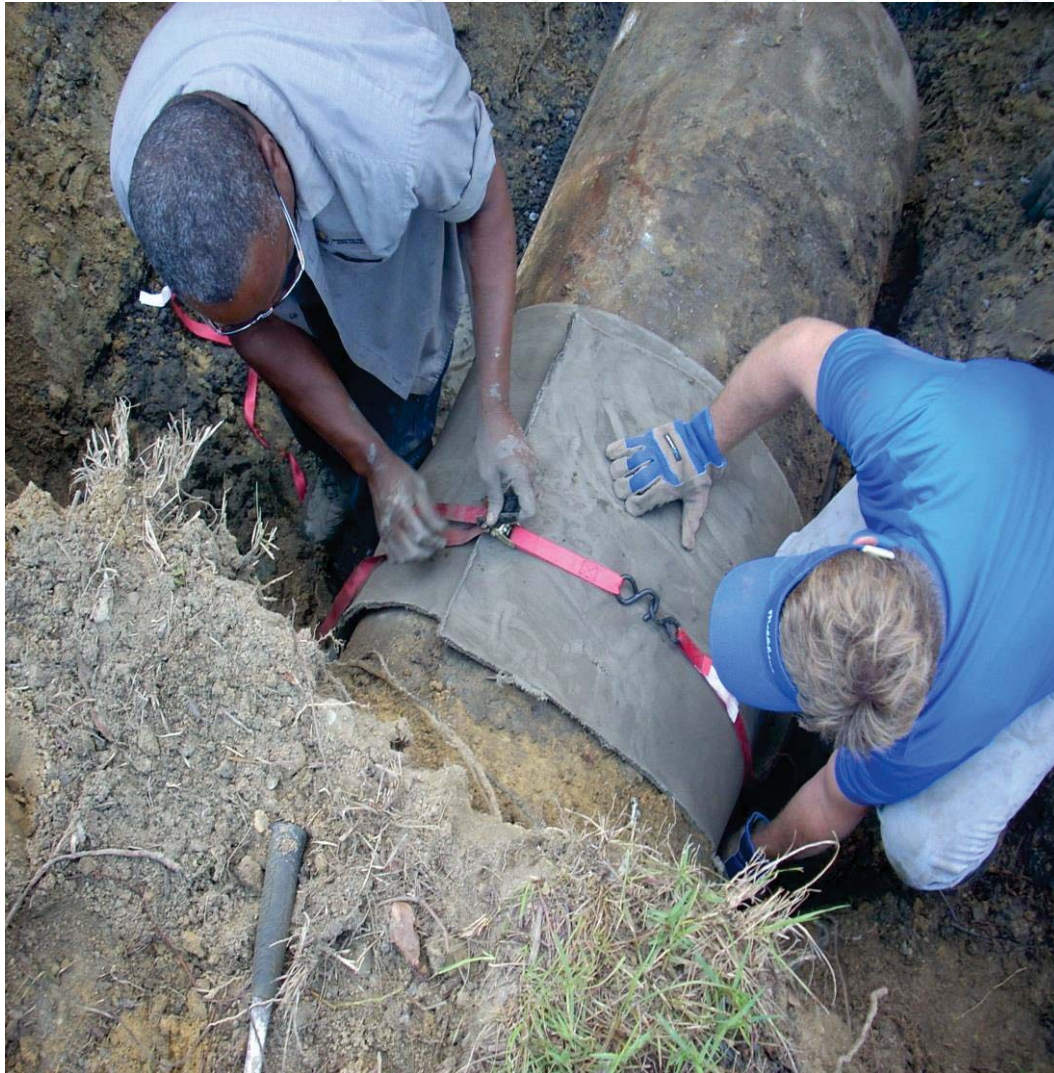
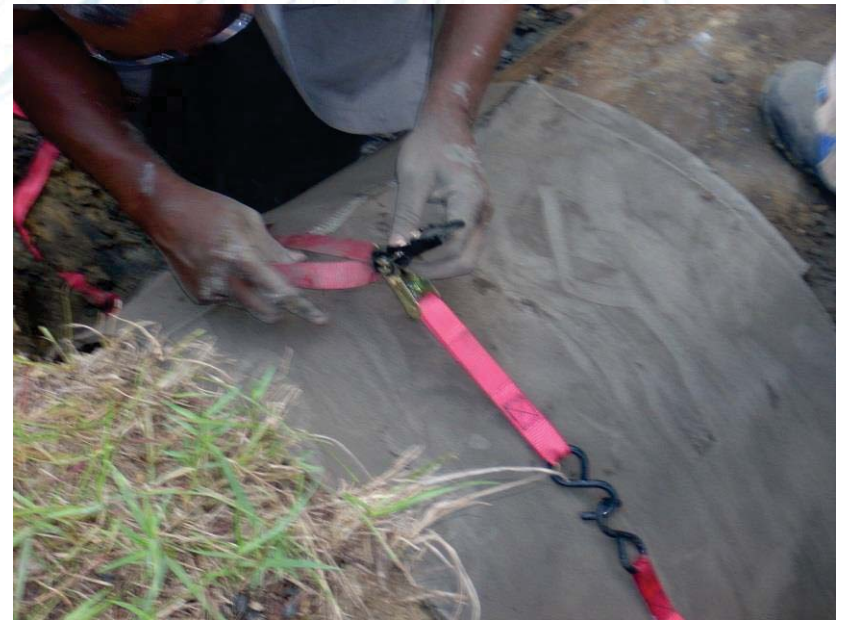
The end piece was replaced and the joint was wrapped in CC8. Straps were used to hold the CC8 in place.

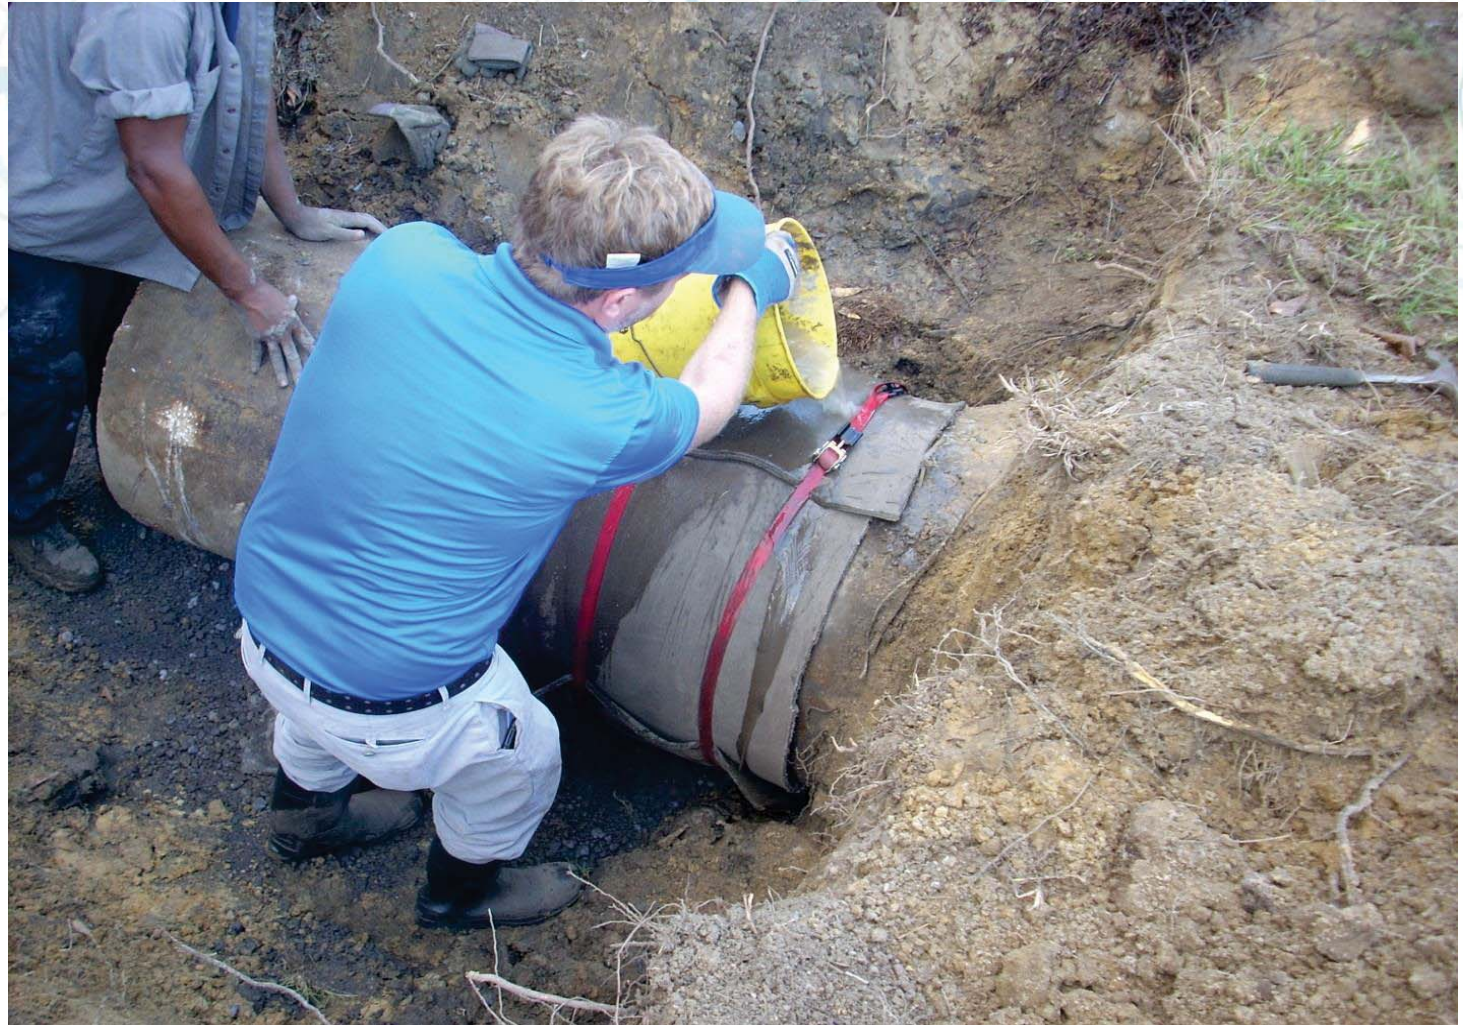
The Concrete Cloth was hydrated using a 5 gallon bucket and water from the nearby creek.
