Using a Bridge for Emergency Slide Repair

US 231 near Laceys Spring, Morgan County, AL

Robert Thompson, P.E. - Senior Principal Engineer/CFO

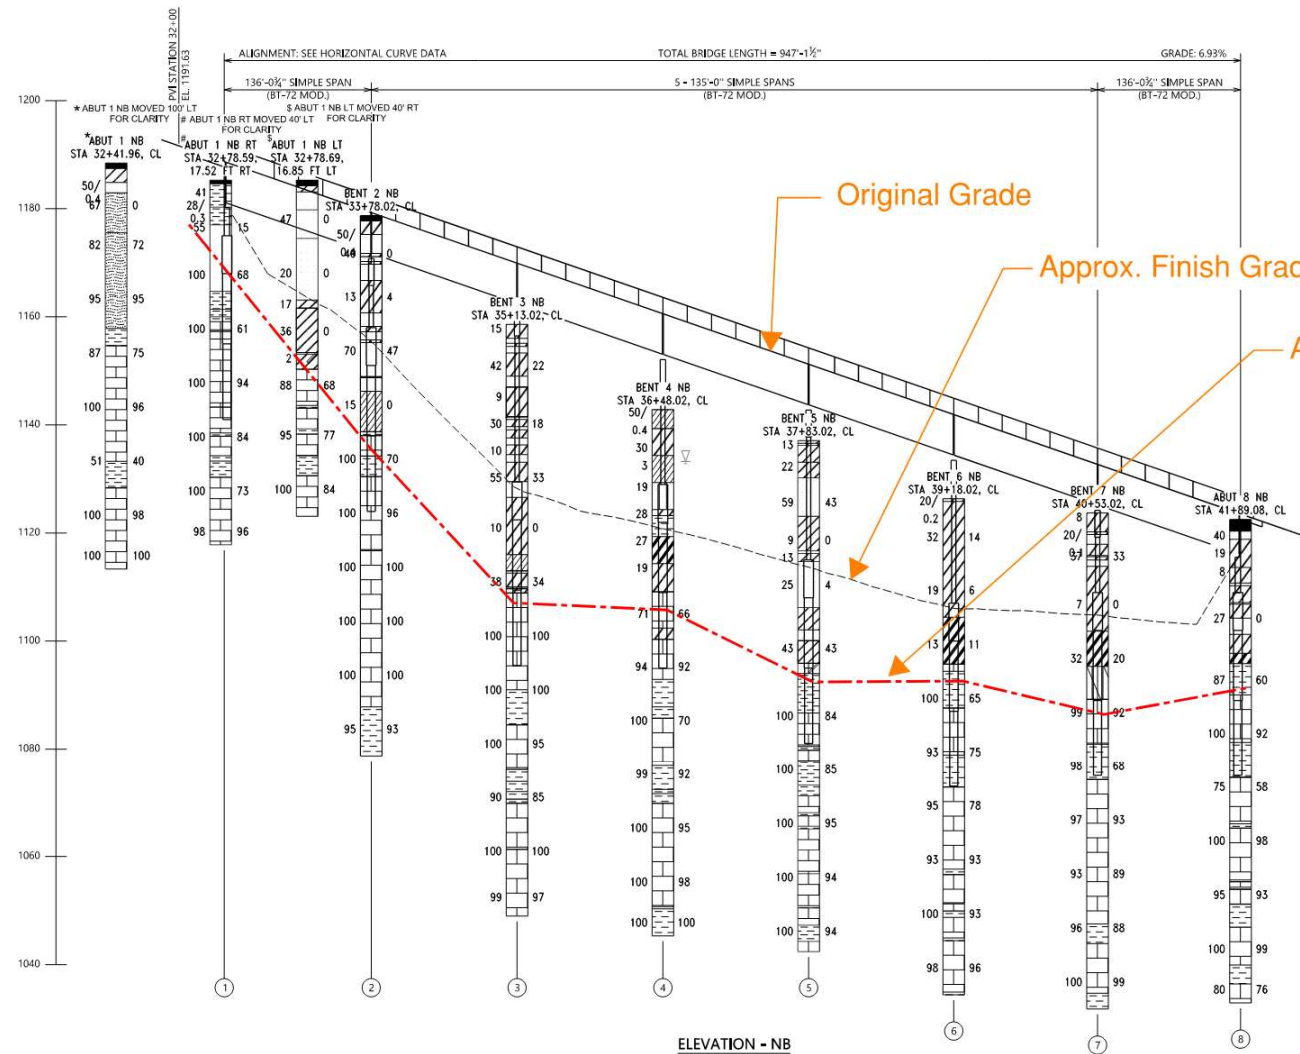
ALABAMA DEPARTMENT OF TRANSPORTATION	
BRIDGE SHEET OF	ALDOT Project No.: ERPR-907(900)
TTL	Reconstruction of Slab Area on SR-53 (US-231)
2018 Stevenson Avenue Tallahassee, FL 32301 904.209.1111 www.ttl.com	from MP 301.3 to MP 301.9
APPROVED:	Morgan County
	TTL Project No. 000200100711.00
DATE: 04/14/2020	BRIDGE SOIL PROFILE
	SHEET BSP-01 OF 2

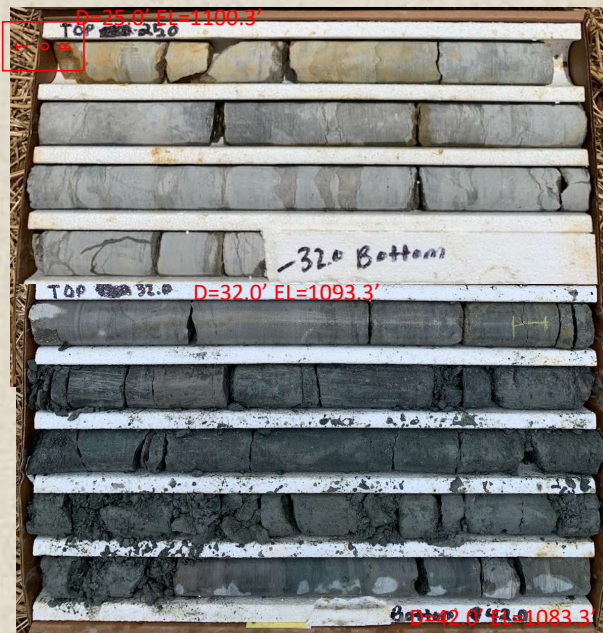
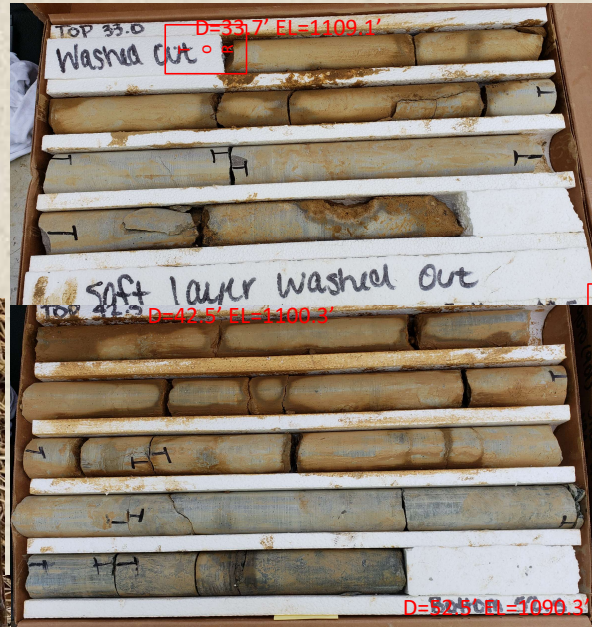
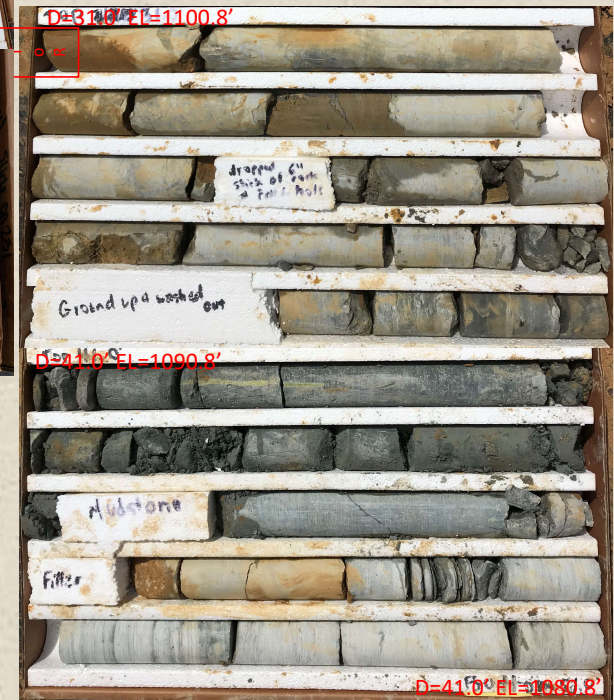
NB Bent 4

NB4 Center
 GS EL = +1142.82 ft
 Depth to Top of Rock = 33.7 ft
 Top of Rock Elevation = +1109.12 ft

NB4 Downhill
 GS EL = +1125.333 ft
 Depth to Top of Rock = 25.0 ft
 Top of Rock Elevation = +1100.333 ft

NB4 Uphill
 GS EL = +1131.760 ft
 Depth to Top of Rock = 31.0 ft
 Top of Rock Elevation = +1100.76 ft

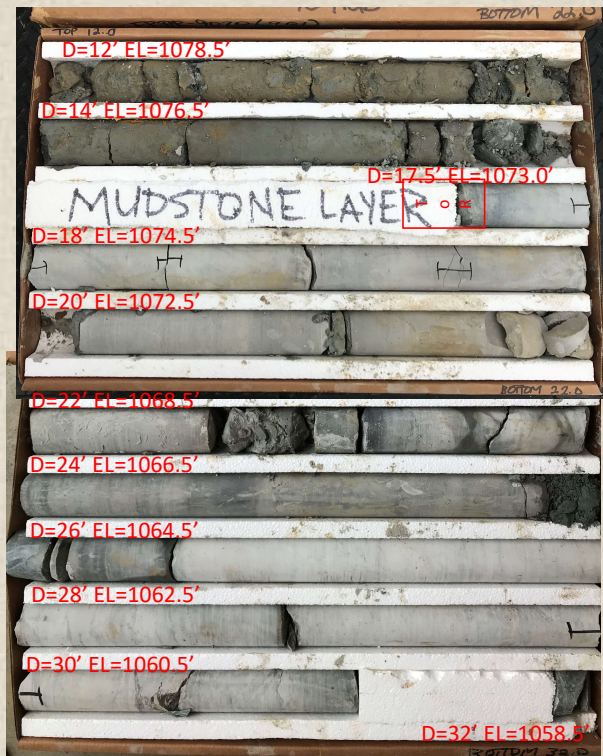
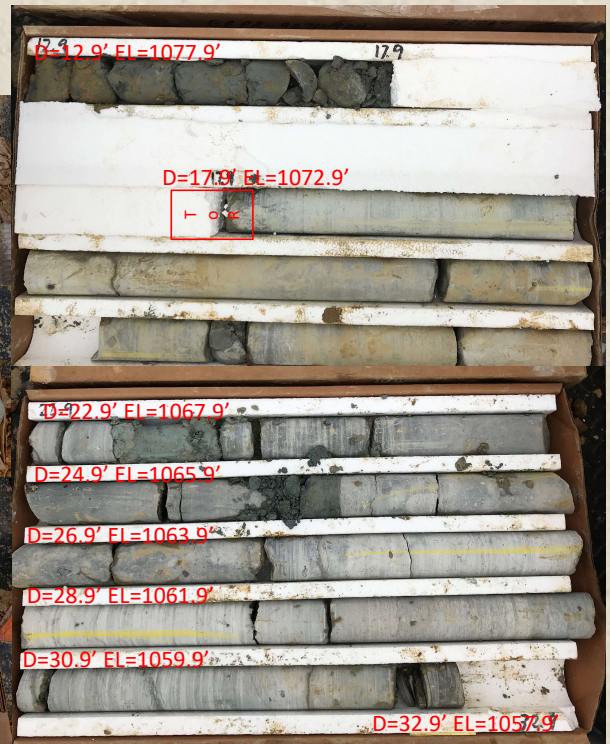
SB Bent 7

SB7 Downhill
 GS EL = +1090.454 ft
 Depth to Top of Rock = 17.5 ft
 Top of Rock Elevation = +1073.0 ft

SB7 Center
 GS EL = +1105.8 ft
 Depth to Top of Rock = 33.4 ft
 Top of Rock Elevation = +1072.4 ft

SB7 Uphill
 GS EL = +1090.777 ft
 Depth to Top of Rock = 17.9ft
 Top of Rock Elevation = +1072.9 ft

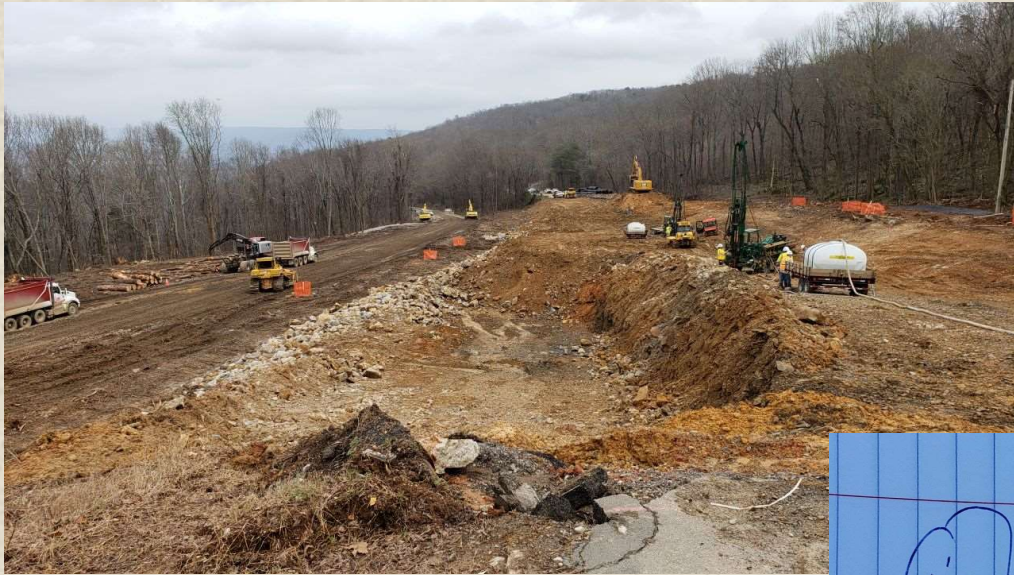
Preliminary Grading Plan to begin work – March 6, 2020

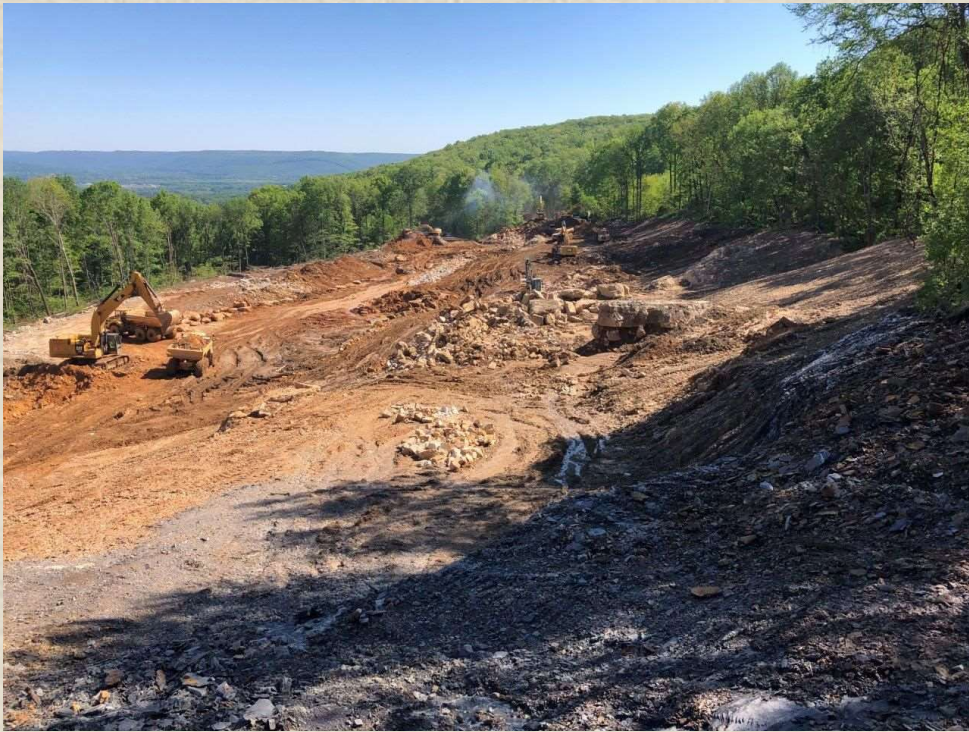
- 220,000 cubic yards removed prior to bridge construction
- Additional excavation at each bent for grade beams

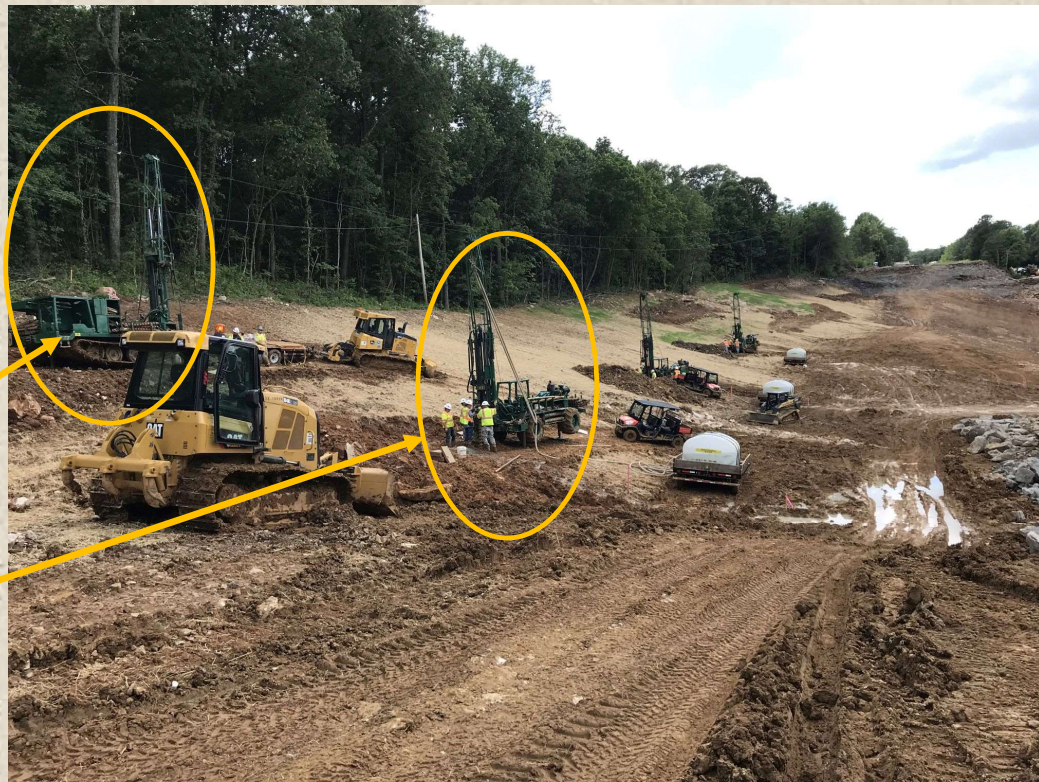
Bent 7 NB Shaft 2 (uphill)

8ft x 1.5in pipe

9.5ft perm casing

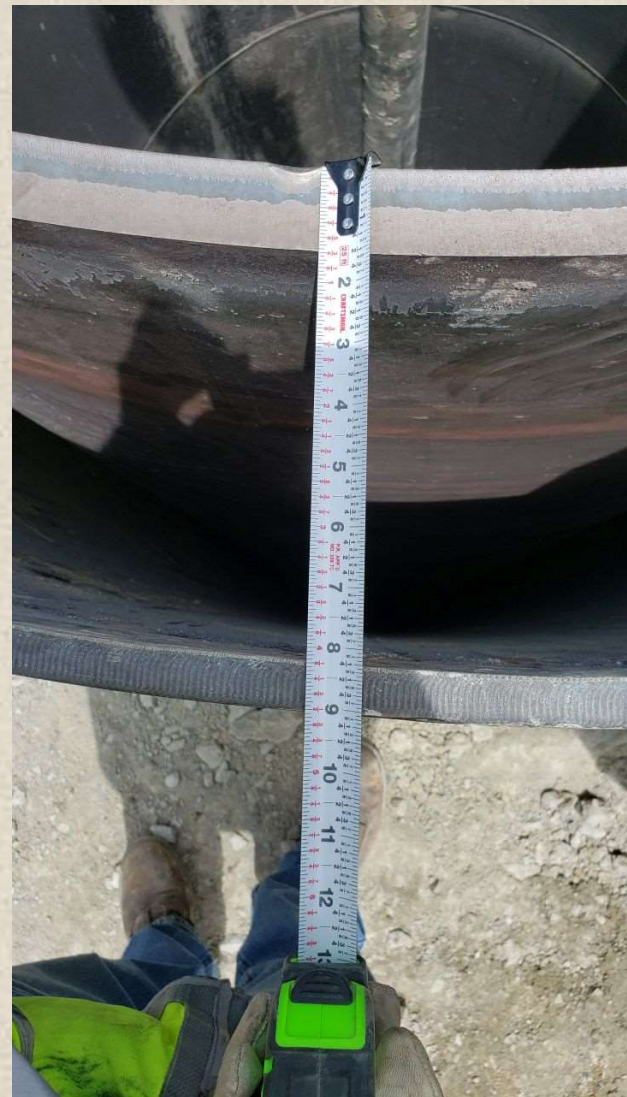
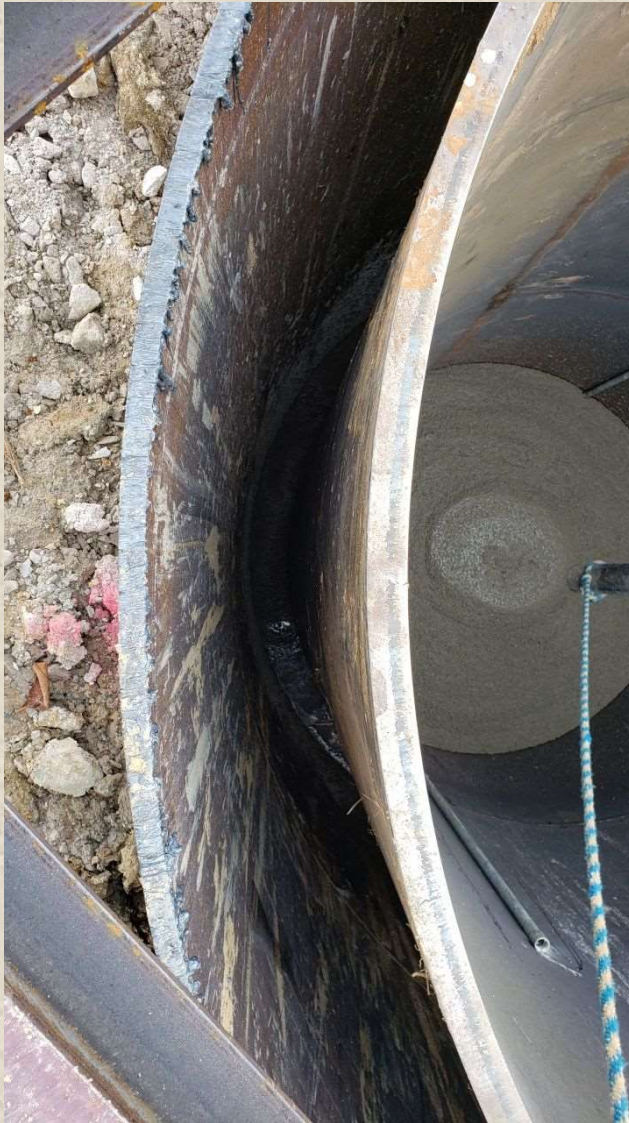
- 2 slick lines delivered concrete between Casing and Structural Pipe
- Pump boom or free fall inside Structural Pipe
- All shafts in the dry
- Specified maximum differential of concrete in/out of Structural Pipe

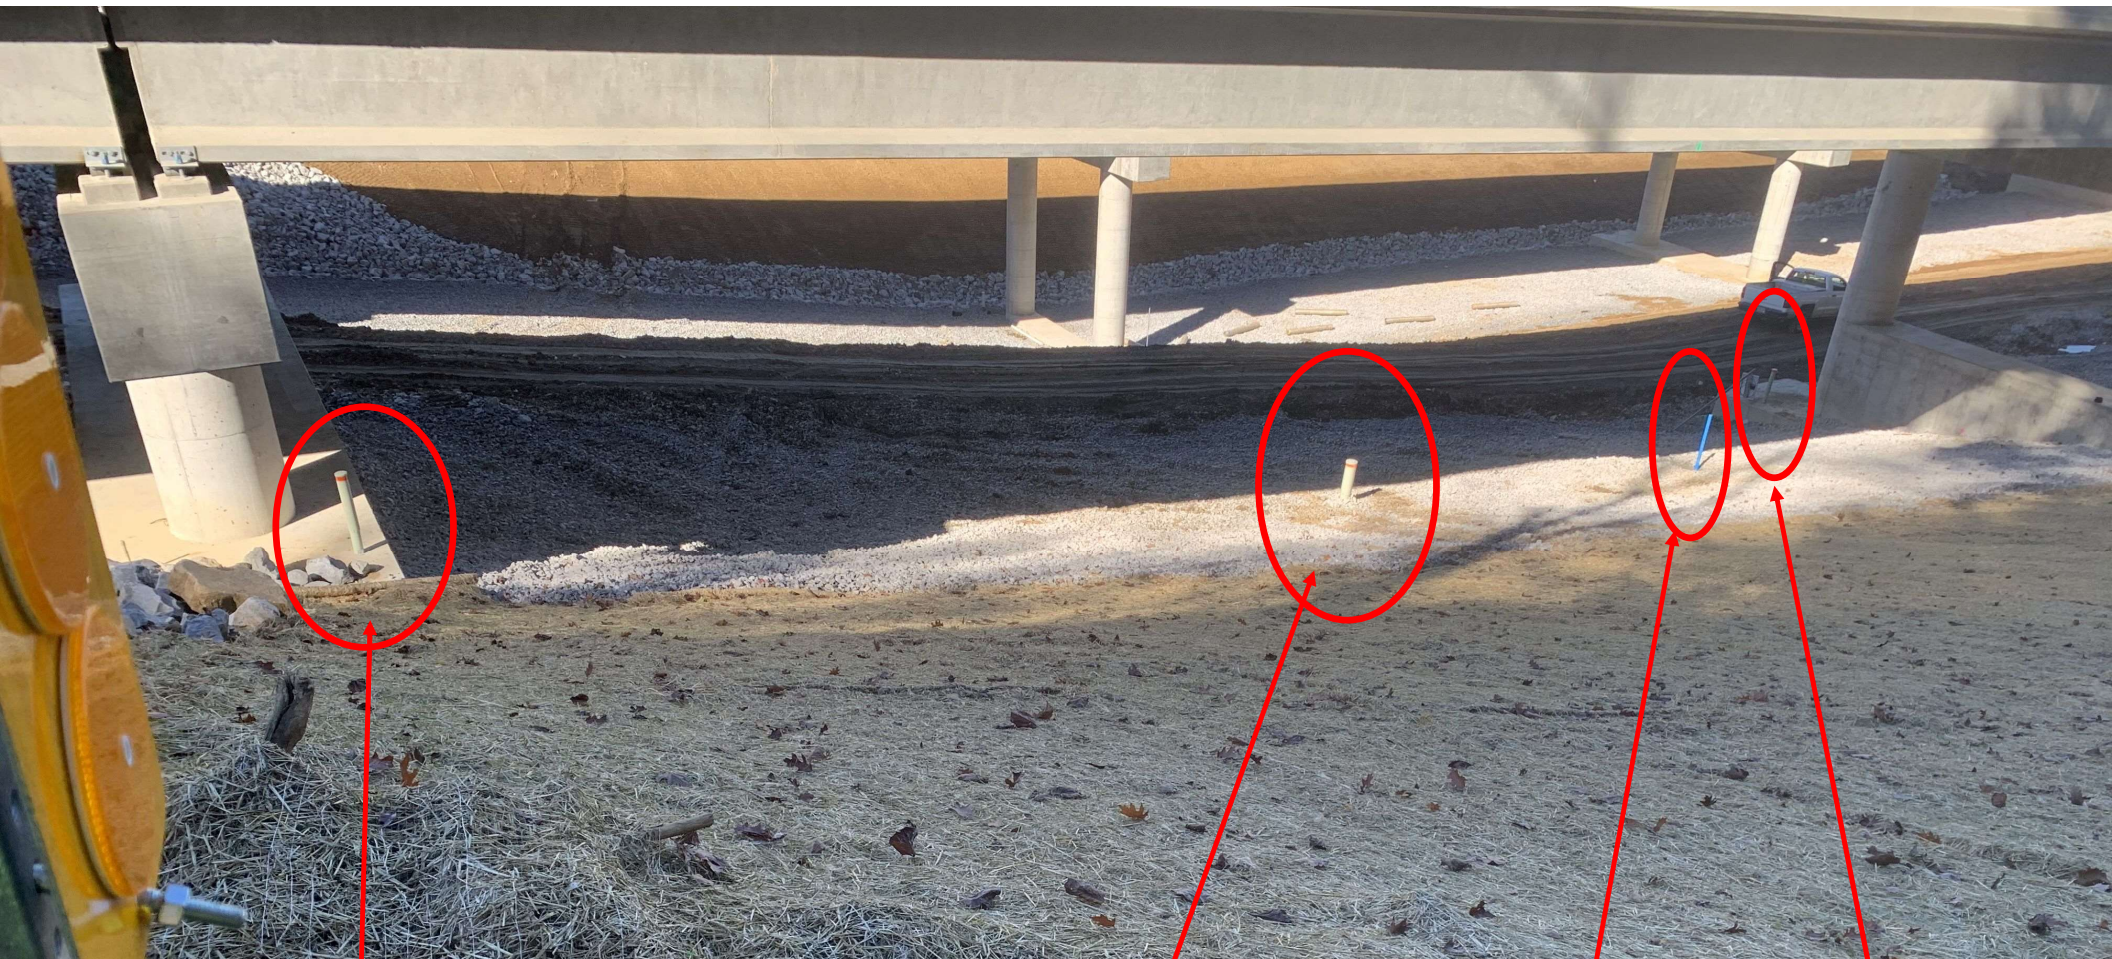
Shape Array Data Interpretation
Bridge: NB Bent: 3 Shaft: Upslope

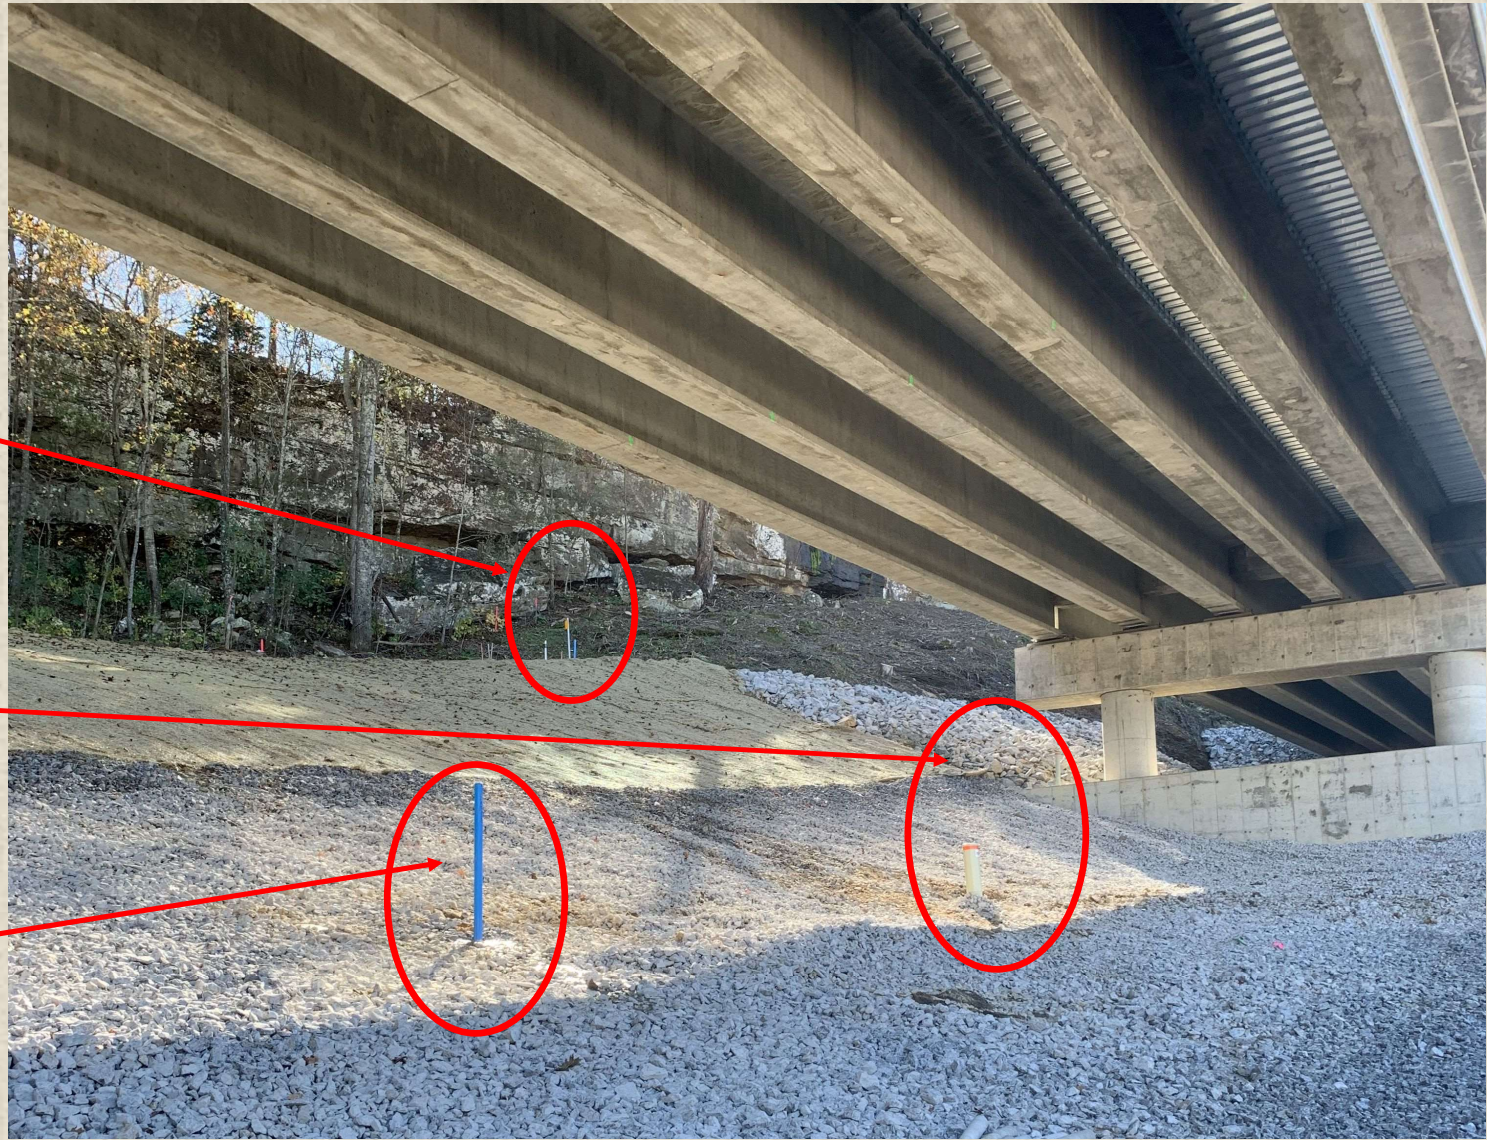
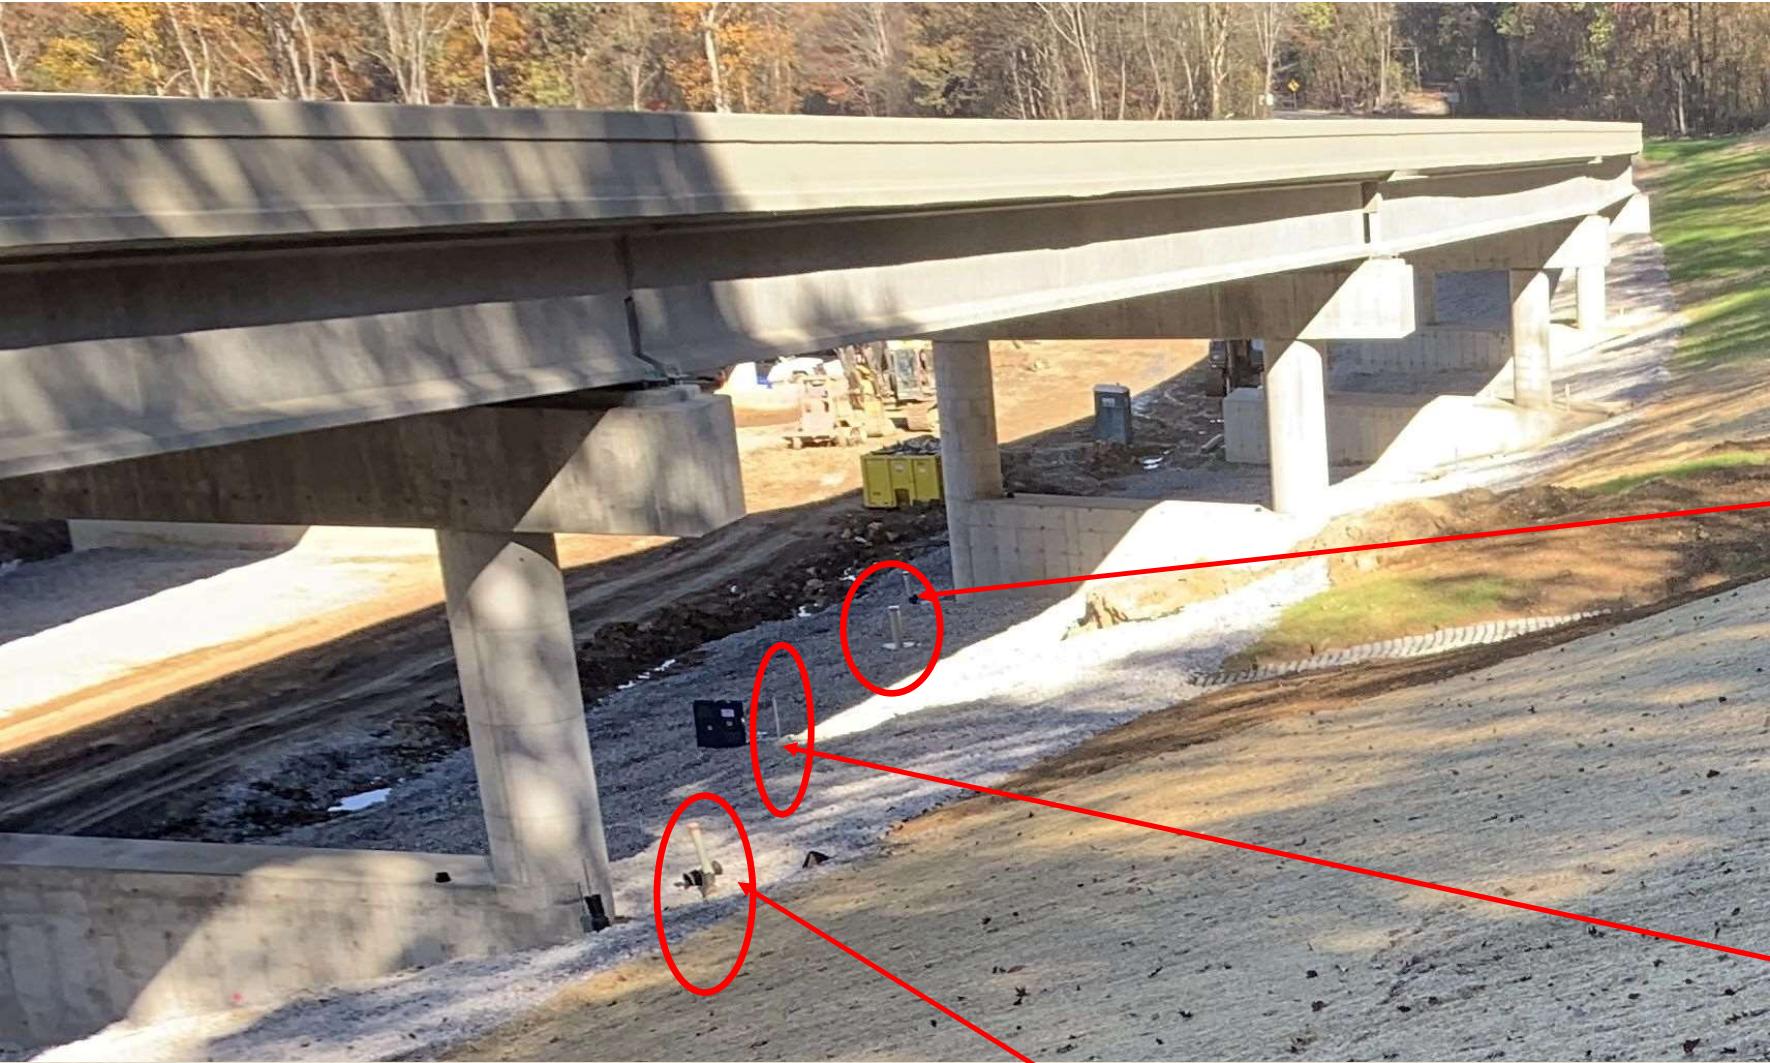
Inclinometer and
Vibrating Wire Piezometer
(Construction)

Vibrating Wire Piezometer

Inclinometer

Vibrating Wire
Piezometer

Free Field
Shape Array

Shaft Shape Array

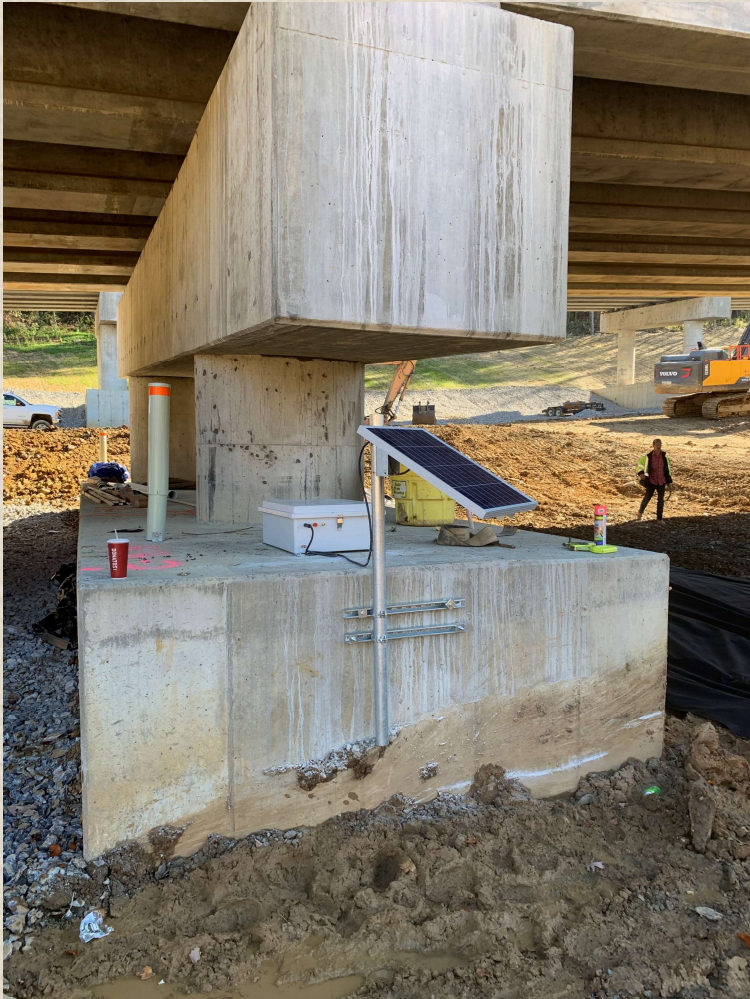
Star Hub and Solar Panel

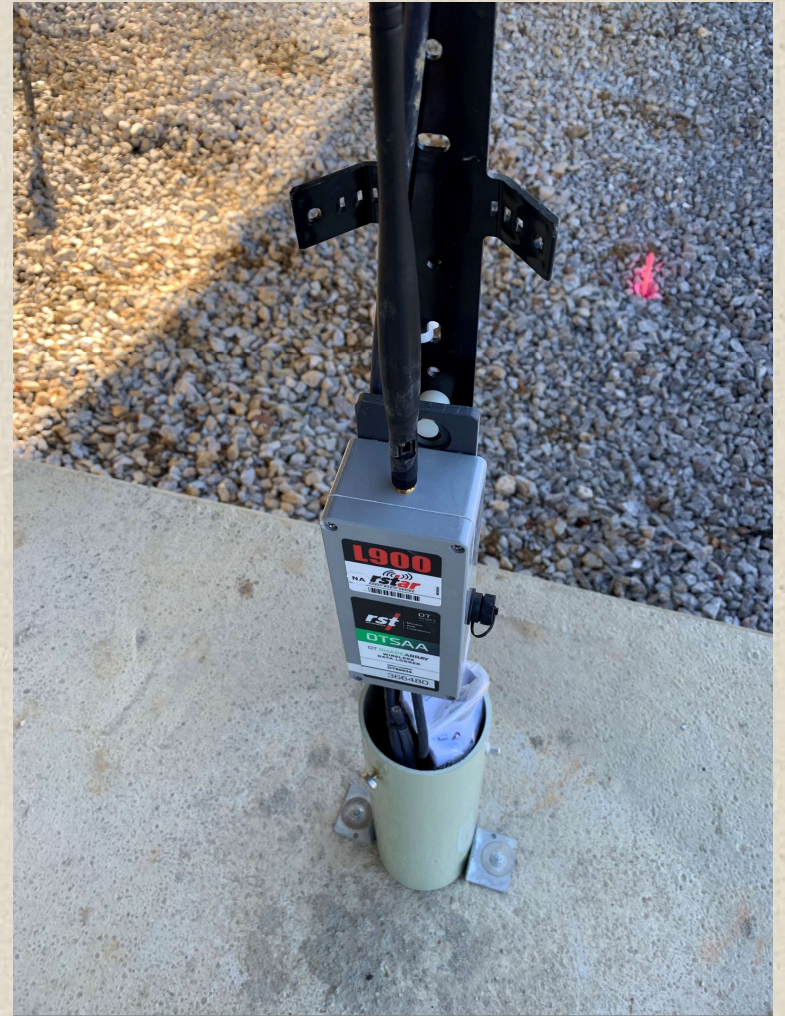
Completed Shaft Install

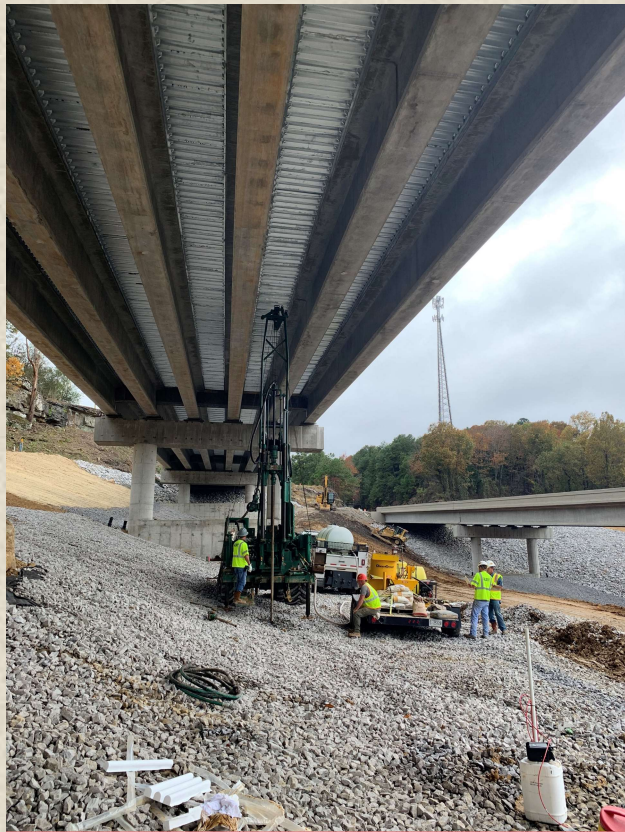
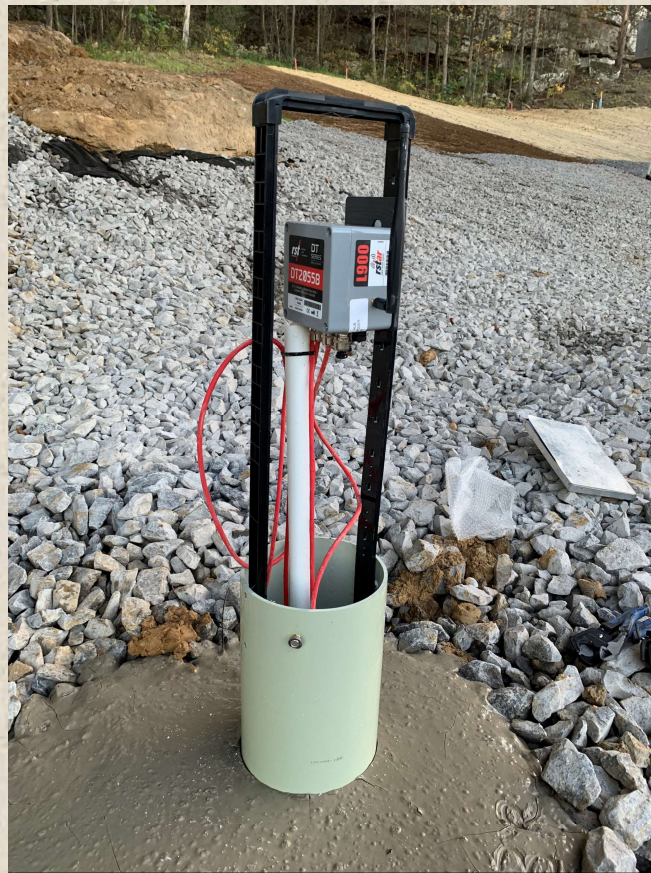
Free Field Shape Array Installation
